NEDU-8-80

MK 12 SSDS HELMET ADJUSTABLE EXHAUST VALVE ASSEMBLY EVALUATION

By:  
M. A. COULOMBE, LT. (N), CF

24 MARCH 1980

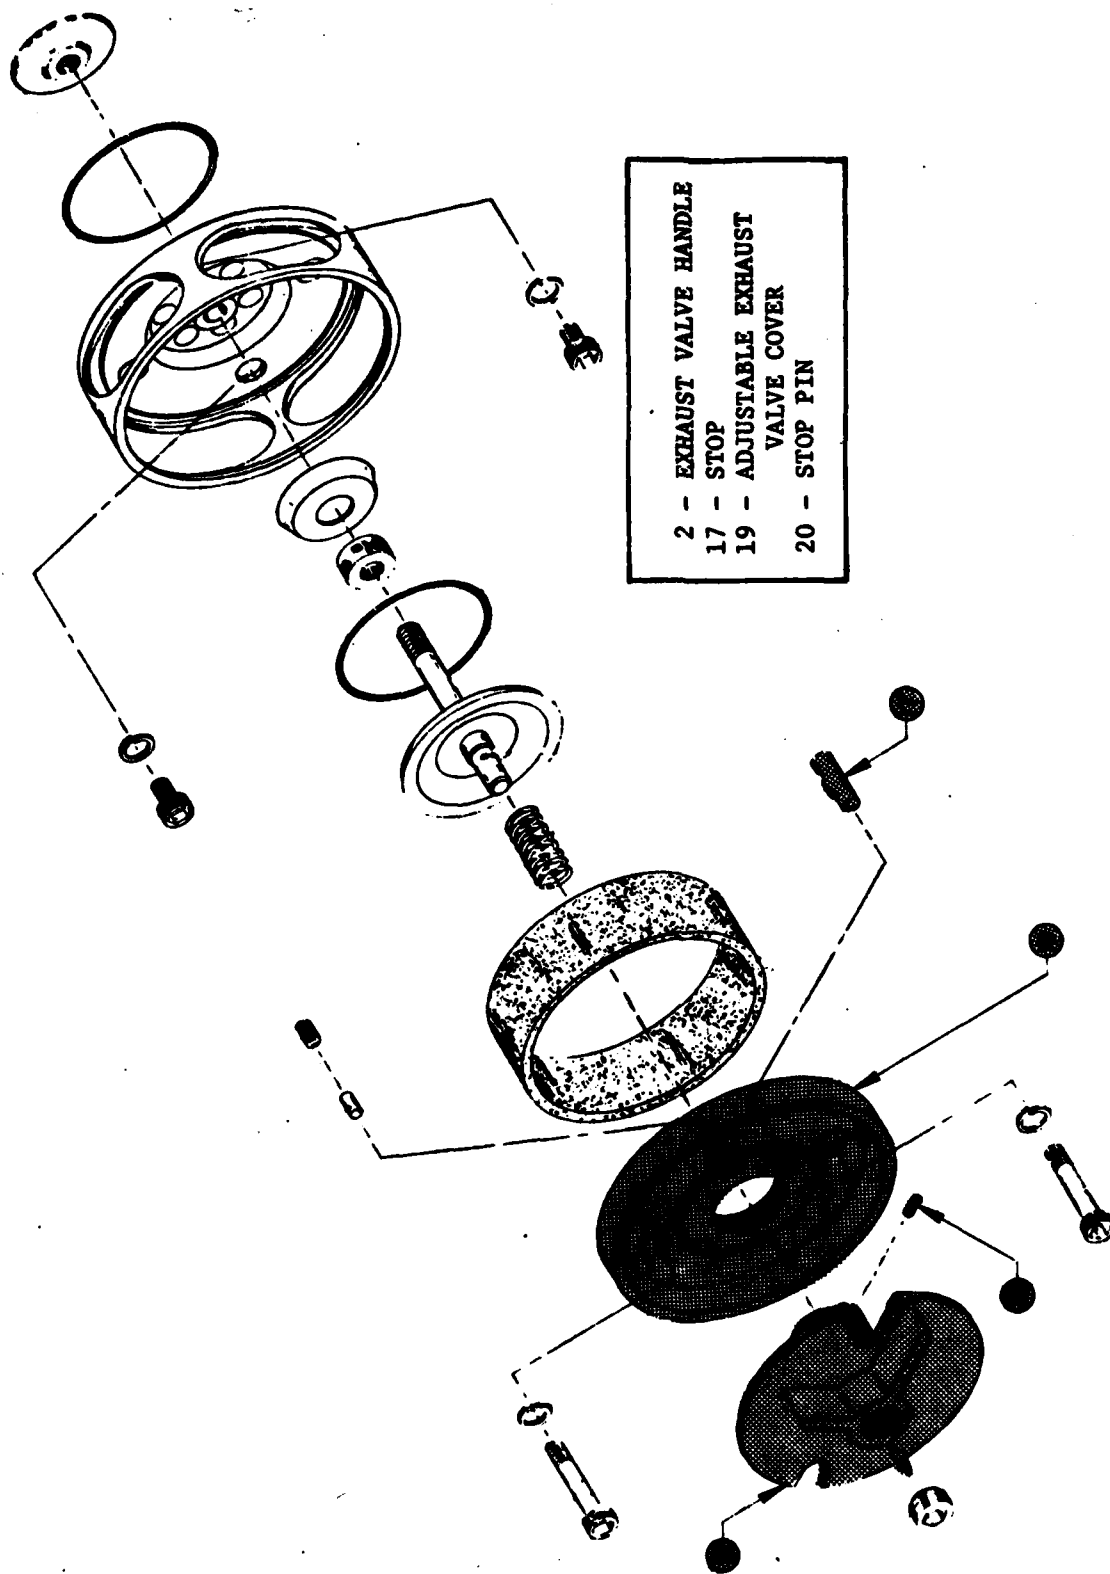
FIGURE 1. MK 12 SSDS HELMET ADJUSTABLE EXHAUST VALVE ASSEMBLY RETROFIT AND DESIGN CHANGE PARTS LOCATION

The stop pins on the helmet adjustable exhaust valve handles (P/N MS16562-211) of the MK 12 SSDS have failed on several occasions both during training and operational dives.

Three stop pin failures were investigated by NSWC, Dahlgren. It was reported that the failures were a result of intergranular fractures due to the brittle characteristics of the stop pin material, which fractured from the force of the stop pin impacting against the stop.

STOP PIN  
(SLOTTED TUBULAR SPRING TYPE/MS 16562 - 211)

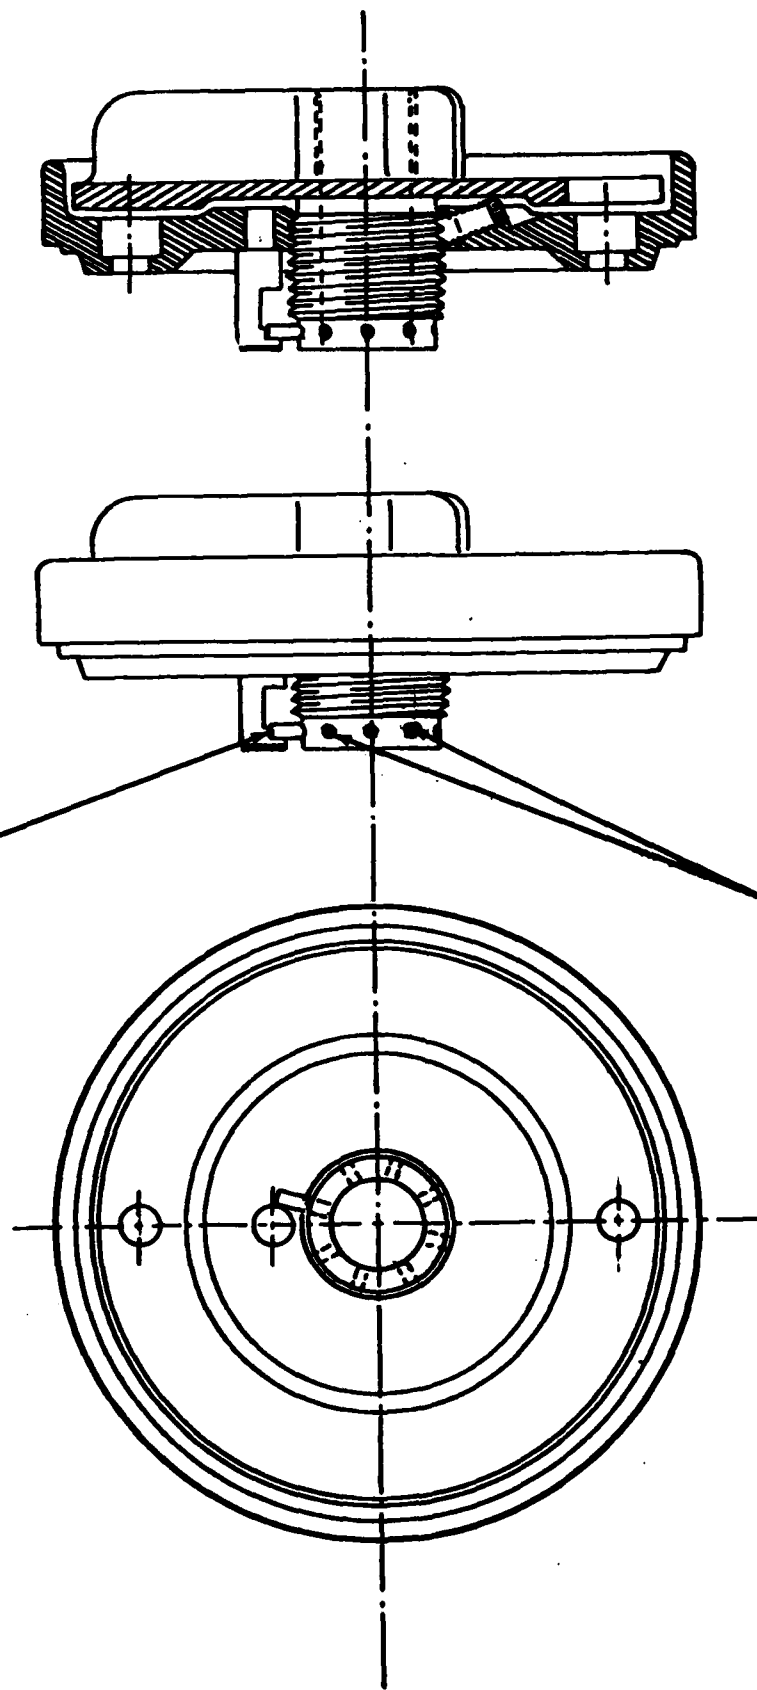
FIGURE 2. PRIMARY FAILURE SITES ON MK 12 SSDS HELMET ADJUSTABLE EXHAUST VALVE ASSEMBLY

A summary of the findings outlined in the memorandum indicated that many of the existing stop pins had been plastically deformed during valve handle assembly. This condition is the result of inserting the tempered stop pin into a .004" to .006" undersized hole in the valve handle barrel. (See Figures 1 and 2).

UNDERSIZED HOLES  
.086 IN. DIAMETER  
(SPECIFIED .090 IN./ .092 IN. ON DRAWING 592-4758555)

d. The valves that failed were manufactured by Morse Diving Company. Inspection of these parts shows that the diameter of the pin holes was  $.086''$  as opposed to the specified  $.090''/.092''$  on the drawing. This undersized hole puts an excessive stress concentration on a pin of this temper. It has been noted that several of the valves, as received from the manufacturer, had these pins split at assembly. It is apparent that if the pin is split at assembly, the ability of the pin to remain in its hole as well as resist bending or breaking is considerably reduced.
